MISSOURI - KANSAS CITY RIVER BASIN,

CARL DREYER LAKE DAM,
MONTGOMERY COUNTY, MISSOURI.
MO. 10158

PHASE I INSPECTION REPORT
NATIONAL DAM SAFETY PROGRAM.

SEPTEMBER, 1980

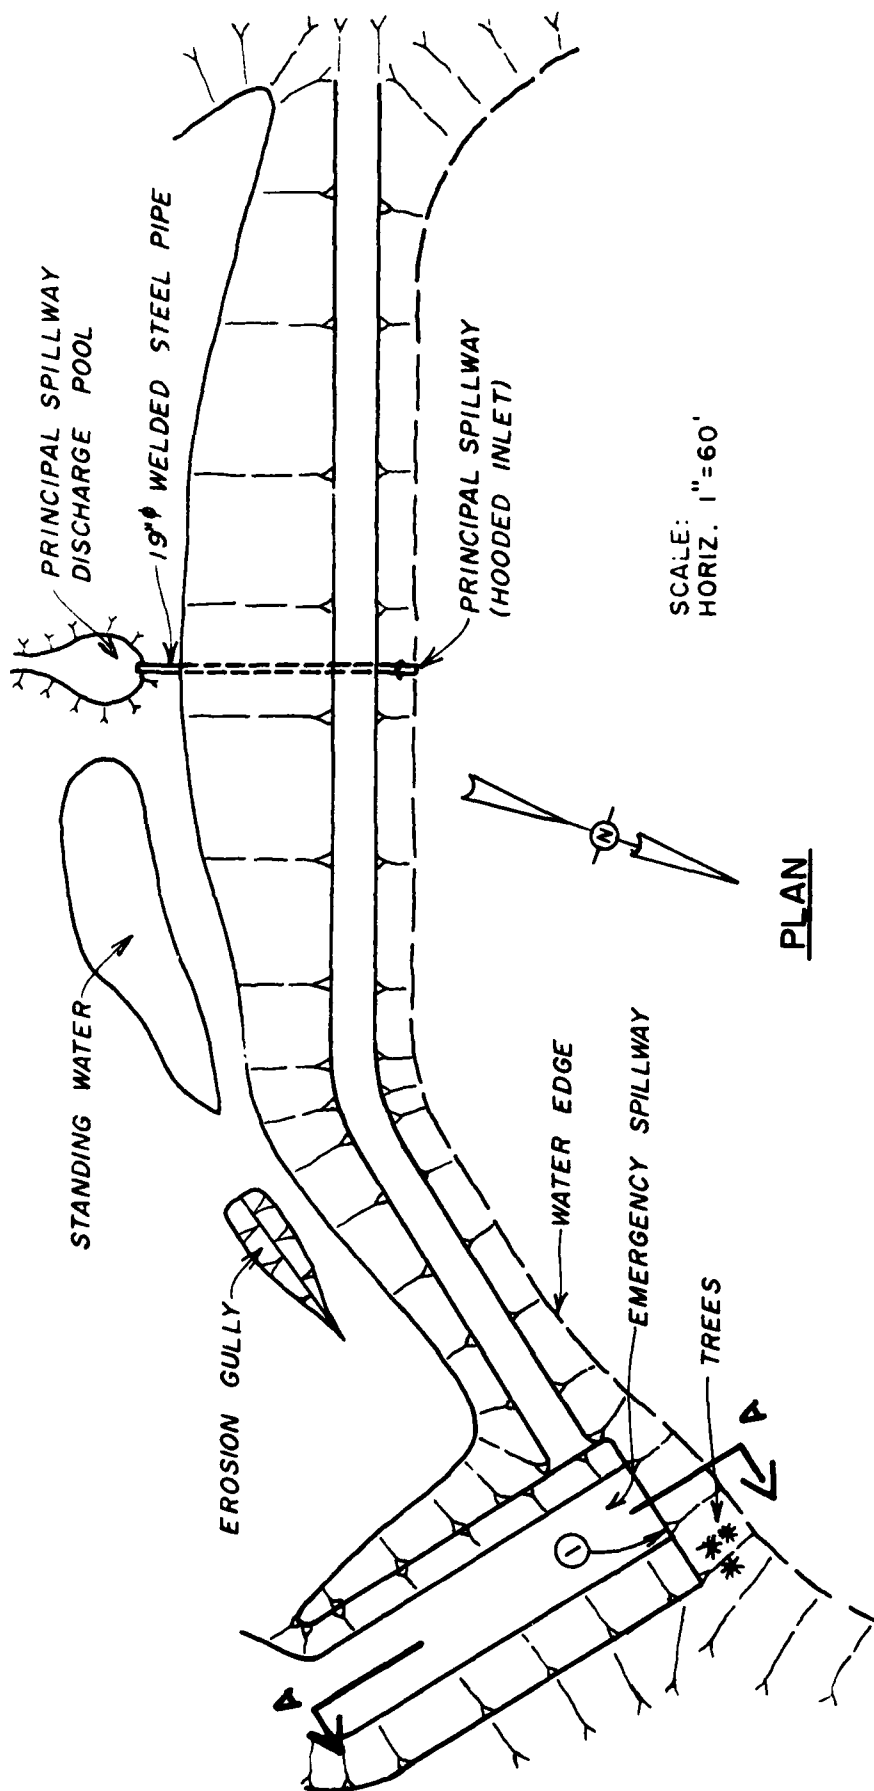
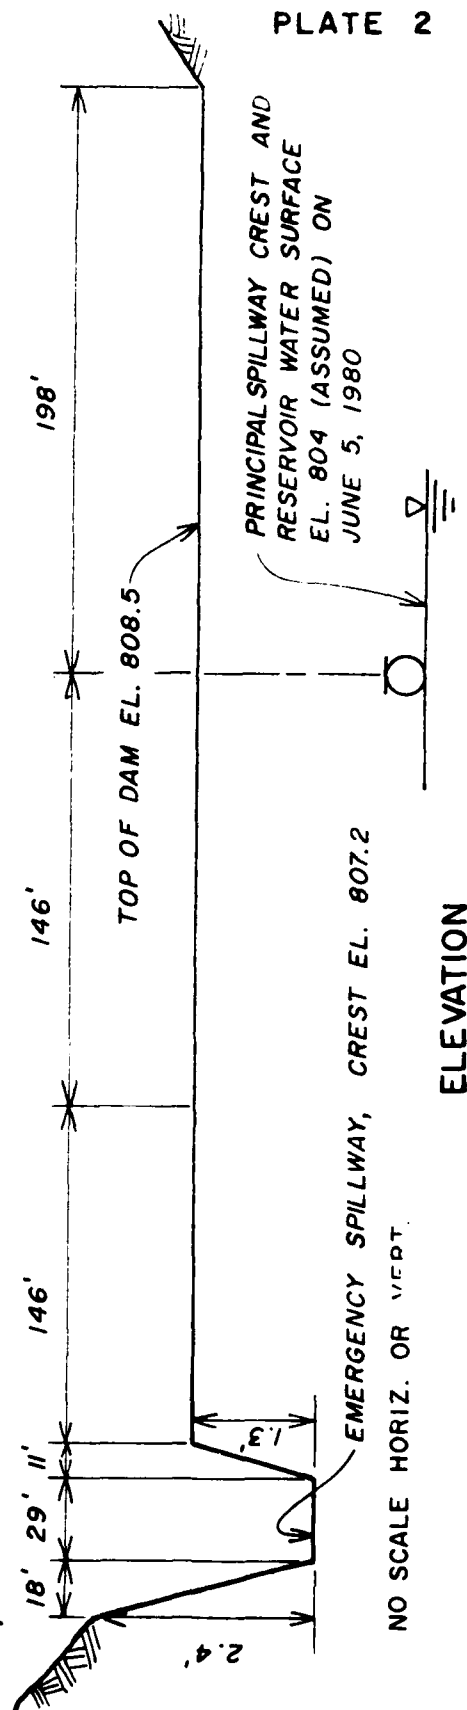
CARL DREYER LAKE DAM (MO. 10158)
PLAN AND ELEVATION

U/S SLOPE VARIES FROM
1 V: 2.5 H TO NEAR VERTICAL
